PROJECT REPRESENTATIVE'S DAILY REPORT

Pg. 1
Report No. 082
Date: 2014-12-15
Day: Monday

Project: Renovation and Addition to Tewksbury Town Hall

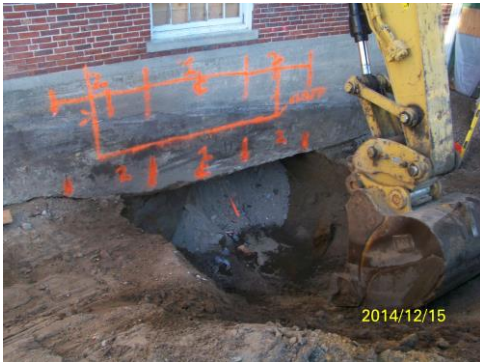
- 4) Site Work: excavating for the addition foundation – encountered ground water at 4' below grade and the excavation caused undermining of the soil from the basement interior. This work was suspended until the contractor installs sheathing on the interior to keep the soil from undermining; continued excavating and installing drain pipe in parking lot

Photo showing excavation for addition foundation resulted in undermining the basement floor. The excavation also revealed water at roughly 4' below grade.

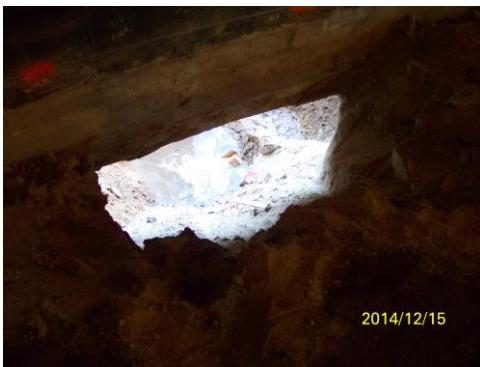
Photo showing interior view of the excavation.

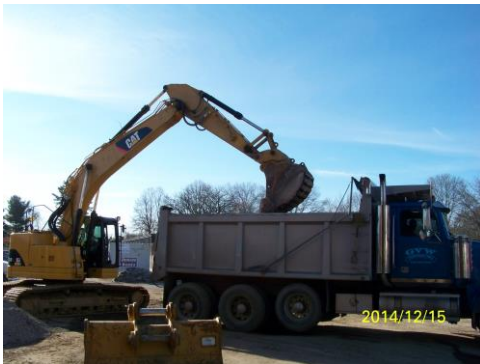
Photo showing workmen removing debris from the site.

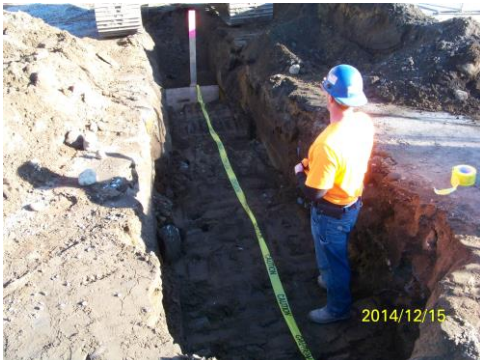
Photo showing workmen having installed drain pipe in the parking lot. This pipe continues from the drain manhole.

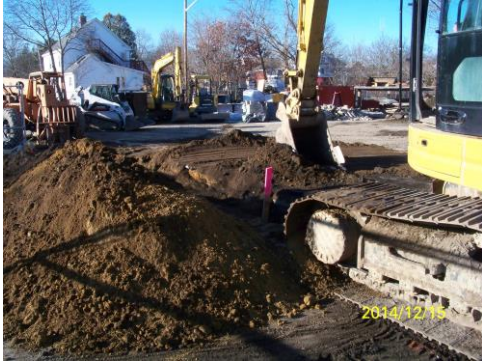
Photo showing backfilling of the excavated area for the drain pipe.

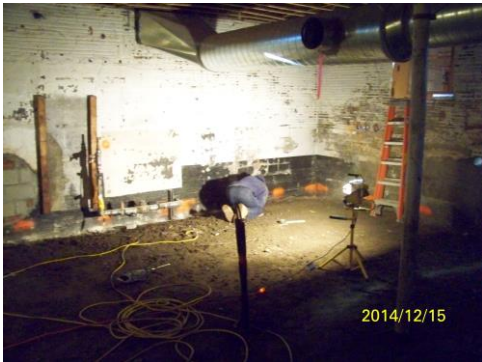
Photo showing workman drilling holes in foundation wall for dowels for concrete slab.

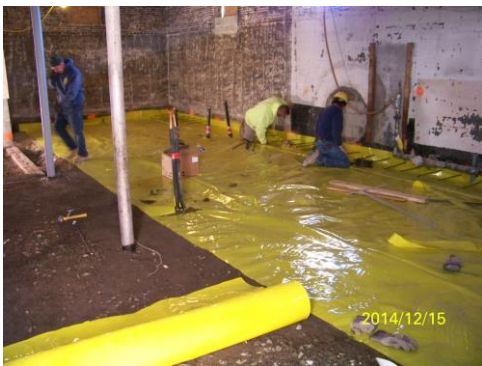
Photo showing vapor being installed in the mechanical room.

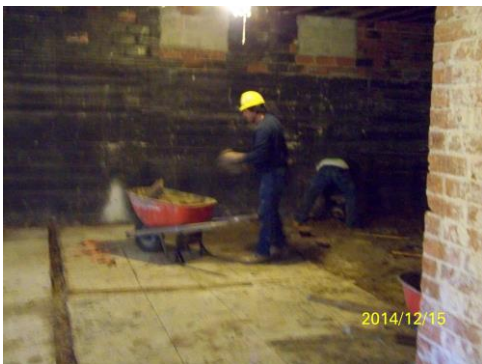
Photo showing workmen removing the sections of concrete from the north wing of the basement.

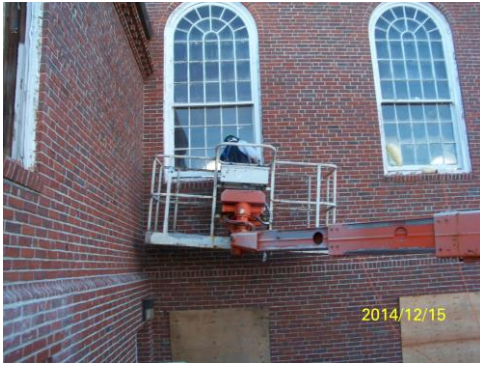
Photo showing mason removing paint from masonry window openings. This is on the north elevation of the meeting hall.

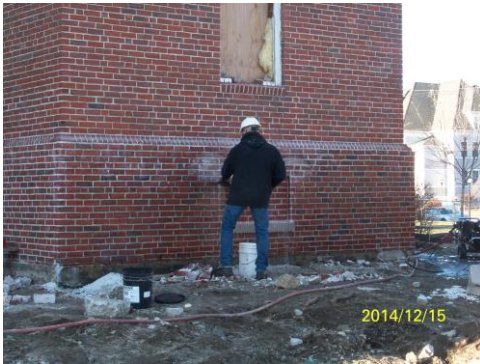
Photo showing mason washing down the new masonry work on the east elevation.

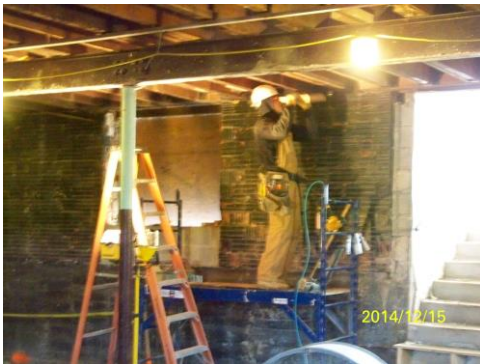
Photo showing carpenter installing tie-backs along the south wall of the meeting hall basement.

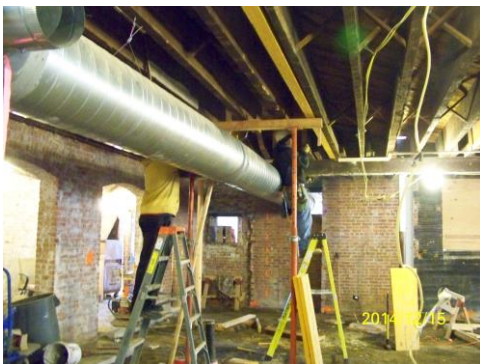
Photo showing carpenters installing the LVL beams at the east end of the basement for the 1st floor of the meeting hall.

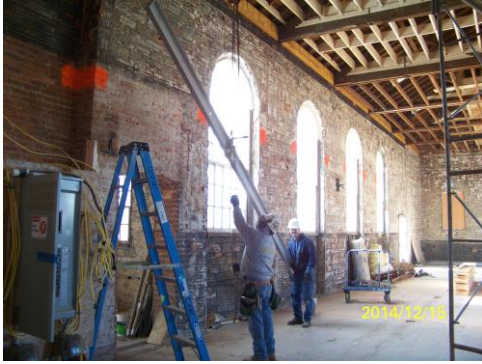
Photo showing workmen raising a channel for the 2nd floor framing.

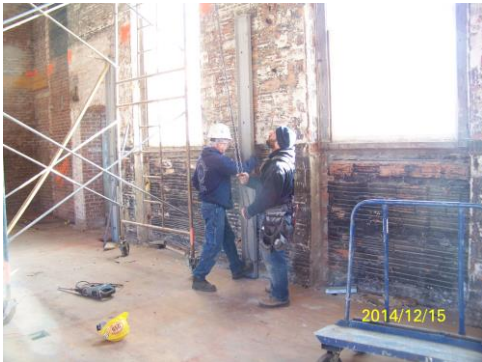
Photo showing another channel being hoisted into place.

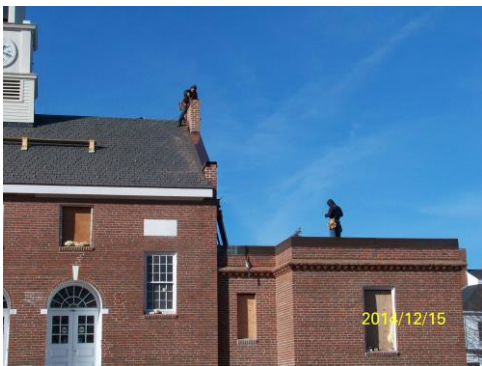
Photo showing roofers installing the parapet cap flashing on the north end of the main building.
